## O<sub>2</sub> Sensors: How They Work & Why They Quit

## ACURA ServiceNews

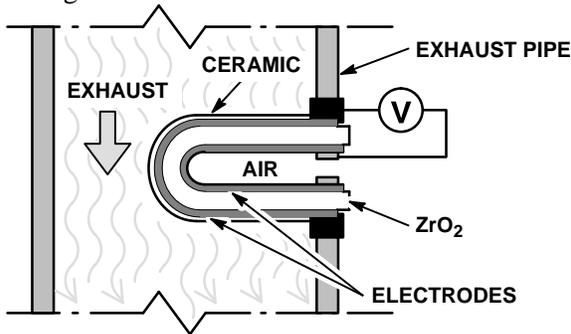
The heart of a typical O<sub>2</sub>S is a thimble-shaped element made of a special material called zirconium dioxide (ZrO<sub>2</sub>). The inner and outer surfaces of this element each have an electrode made of a layer of thin porous platinum. The O<sub>2</sub>S is designed so that the inner surface of this element is exposed to ambient air (the atmosphere), while the outer surface, which also has a porous ceramic coating, is exposed to the exhaust gases.

So what makes an O<sub>2</sub>S stop working properly? Carbon from exhaust? Sounds logical, but no, the number one enemy of an O<sub>2</sub>S is silicone.

When the exhaust side of the element is exposed to silicone, the pores of the protective ceramic coating become clogged. Once this occurs, the exhaust side receives less oxygen. As a result, the O<sub>2</sub>S generates more voltage than it normally would for a given air/fuel mixture. This may cause the ECM to lean the mixture enough to cause driveability

If the ambient air side of the element is contaminated with silicone, the porous electrode becomes clogged, reducing the oxygen on that side. Then the O<sub>2</sub>S will generate less voltage, so the ECM tries to compensate by richening the mixture. This too may deteriorate driveability or trigger the MIL.

Sometimes the source of the silicone may be the fuel, but the more likely sources are the silicone sprays, greases, and adhesives used in most service departments these days. When you use these products, don't let them get into the engine's air intake tract, the exhaust system (upstream of the O<sub>2</sub>S), or the vents on the O<sub>2</sub>S.

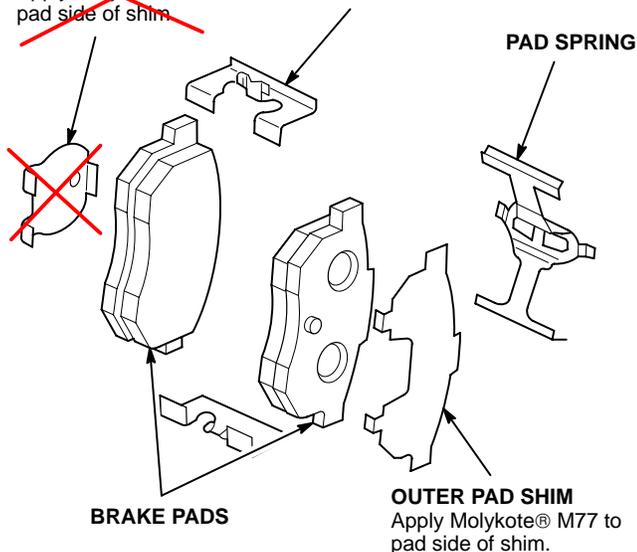
## '94 Integra: No Inner Brake Pad Shims

The rear inner brake pad shim shown on page 19-23 of the '94 Integra S/M shouldn't be there. Cross it out; the car doesn't use an inner shim. The '95 Integra S/M has been corrected.

### ~~INNER PAD SHIM~~
