ACURA ServiceNews

BSN 17234 (9506)

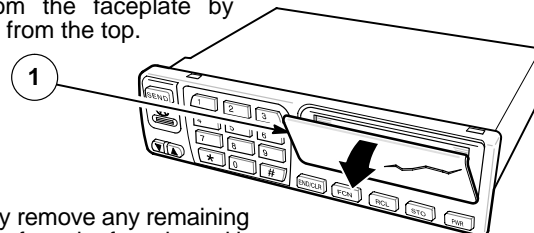
Remove the damaged display lens from the faceplate by prying it from the top.

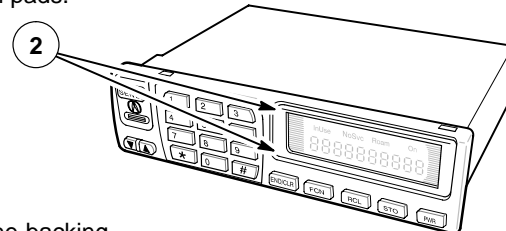
Carefully remove any remaining adhesive from the faceplate with the alcohol pads.

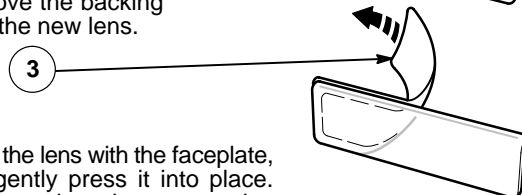
Remove the backing from the new lens.

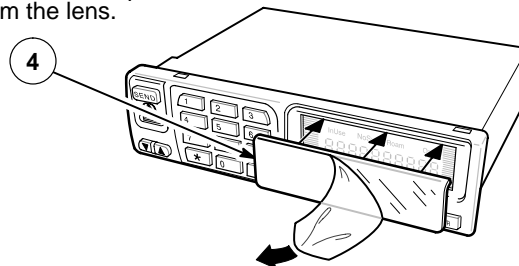
Align the lens with the faceplate, and gently press it into place. Remove the clear protective facing from the lens.

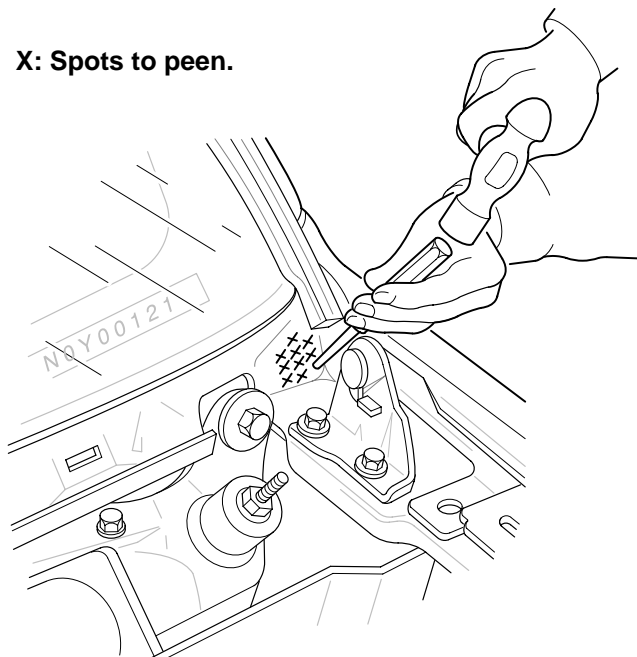
A creaking or popping noise from the area where the A-pillar and dashboard meet on a '94-'95 Integra may be caused by movement between several layers of sheet metal. The noise can usually be reproduced by driving the car through a bumpy turn or in and out of a driveway at an angle to twist the body.

X: Spots to peen.

If the noise is definitely coming from the base of the A-pillar, remove the cowl cover to expose where the bulkhead, the A-pillar, and the fender support come together behind the hood hinge. Using a dull center punch, a hammer, and a fair amount of aggression, peen the welded area 10 to 12 times. If the noise persists, remove the A-pillar trim, and peen the welded area from inside the car. Once you're satisfied that the noise is gone, apply touch-up paint as needed.

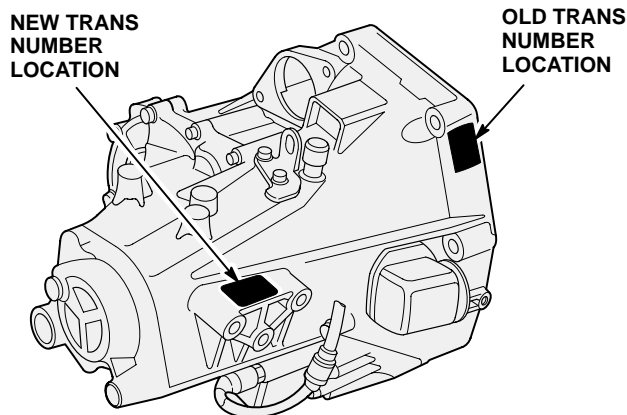
Beginning with May '95 production, the transmission number location was changed on '95 Integra manual transmissions. This change makes room for a new parts marking tag on '96 models that will show the car's VIN.
