ACURA ServiceNews

BSN 17234 (9506)

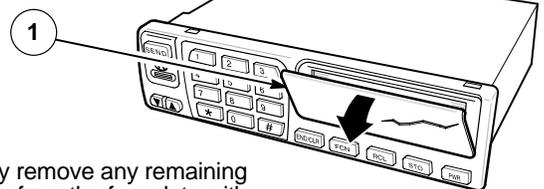
If a customer damages the display lens on an in-dash cellular telephone, you can replace it. The replacement lens is P/N 08E01-SV4-900RE, and it comes with alcohol pads to help remove any remaining adhesive from the phone’s faceplate.

Remove the damaged display lens from the faceplate by prying it from the top.

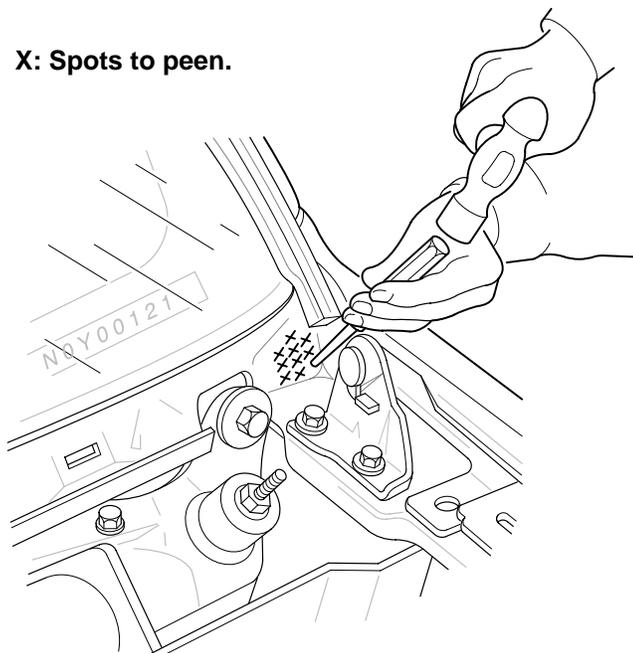
X: Spots to peen.

Integra Creaks/Pops From A-Pillar/Dash

A creaking or popping noise from the area where the A-pillar and dashboard meet on a '94-95 Integra may be caused by movement between several layers of sheet metal. The noise can usually be reproduced by driving the car through a bumpy turn or in and out of a driveway at an angle to twist the body.

If the noise is definitely coming from the base of the A-pillar, remove the cowl cover to expose where the bulkhead, the A-pillar, and the fender support come together behind the hood hinge. Using a dull center punch, a hammer, and a fair amount of aggression, peen the welded area 10 to 12 times. If the noise persists, remove the A-pillar trim, and peen the welded area from inside the car. Once you're satisfied that the noise is gone, apply touch-up paint as needed.

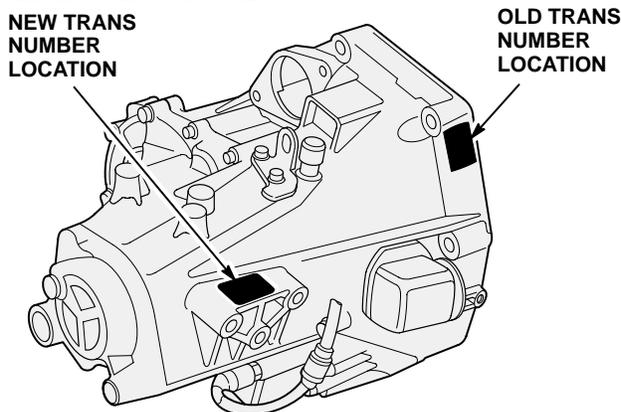
Trans Number Moves on Integra M/T

Beginning with May '95 production, the transmission number location was changed on '95 Integra manual transmissions. This change makes room for a new parts marking tag on '96 models that will show the car's VIN.
