## Beverage Holder Does Not Open or Close Properly

The beverage holder does not open, or it will not stay latched and closed.

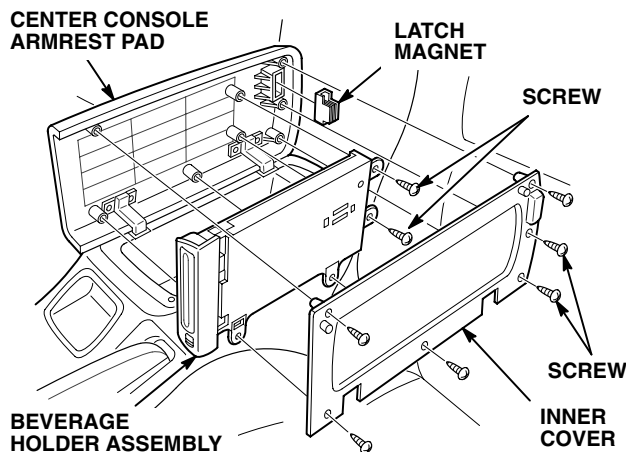
1. Lift up the center console armrest pad, and remove the inner cover (six screws) and the latch magnet.
2. Remove the two screws attaching the beverage holder assembly to the center console armrest pad; then, remove the beverage holder assembly.

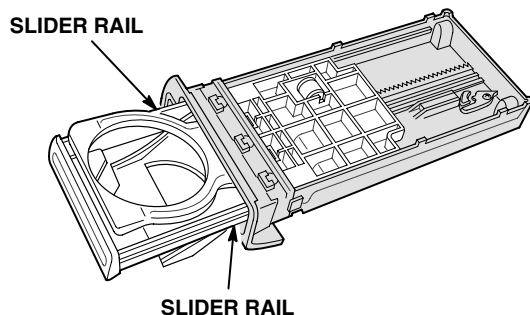
3. Inspect the beverage holder slider rails for breakage.

- If the slider rails are OK, go to step 4 to continue the repair.
- If the slider rail on either side of the beverage holder is broken, replace the beverage holder assembly with the part listed under PARTS INFORMATION to complete the repair.

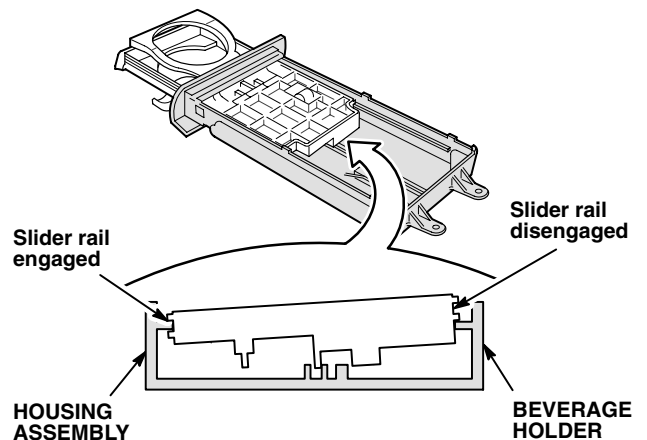
4. Check the beverage holder for contamination (beverage spills, dirt, etc.).
  - If the beverage holder is clean, go to step 5.
  - If the beverage holder is contaminated, clean it with a mild soap and water solution. Do not immerse the beverage holder assembly in the soapy water; that could dilute the grease that controls the opening speed of the beverage holder.
5. Check the engagement between the beverage holder slider rails and the housing assembly slider rails.

- If the slider rails are engaged, go to step 6.
- If the slider rails are disengaged, first reposition the beverage holder slider rails in the housing assembly, and then go to step 7.

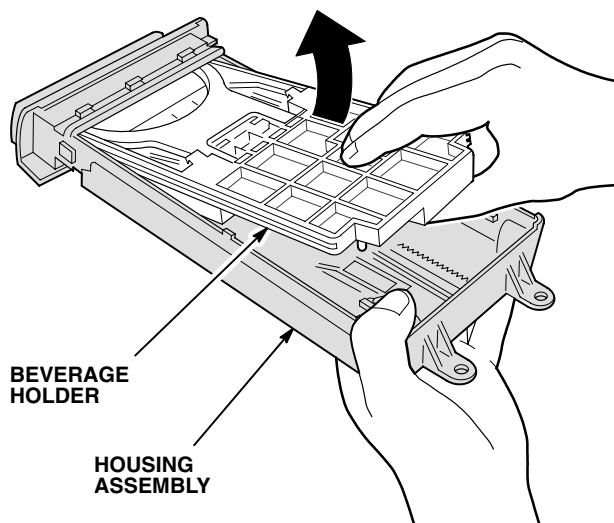
6. Close the beverage holder, and check the latching function.
  - If the beverage holder latches, go to step 11.
  - If the beverage holder does not latch, continue with step 7.
7. Disengage the beverage holder from both sides of the housing assembly slider rails to allow access to the metal lock pin.

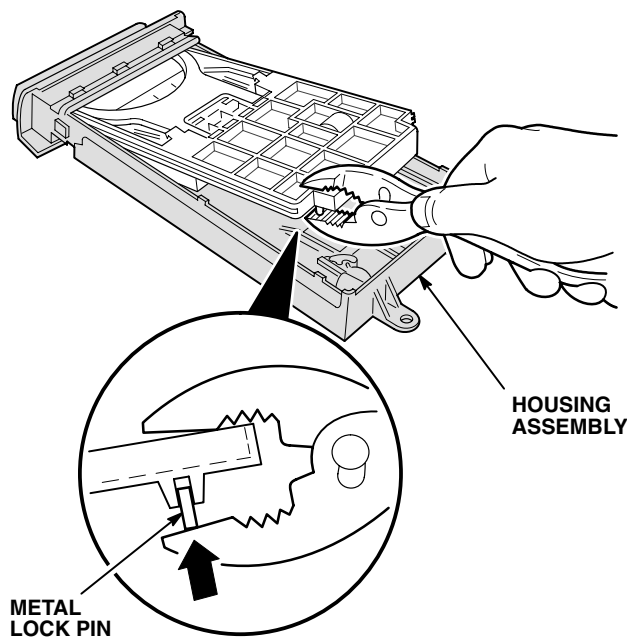
8. Push on the metal pin until it is fully seated.

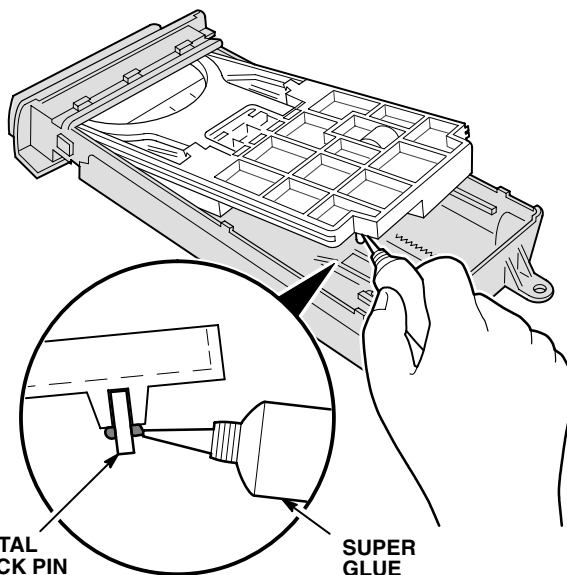
9. Apply a small amount of cyanoacrylate (super glue) around the base of the pin. Allow the glue to dry before reassembling.
