MODEL  
LEGEND  
SEDAN

BULLETIN NO.  
91-024

## RECALL: Automatic Transmission Shift Cable

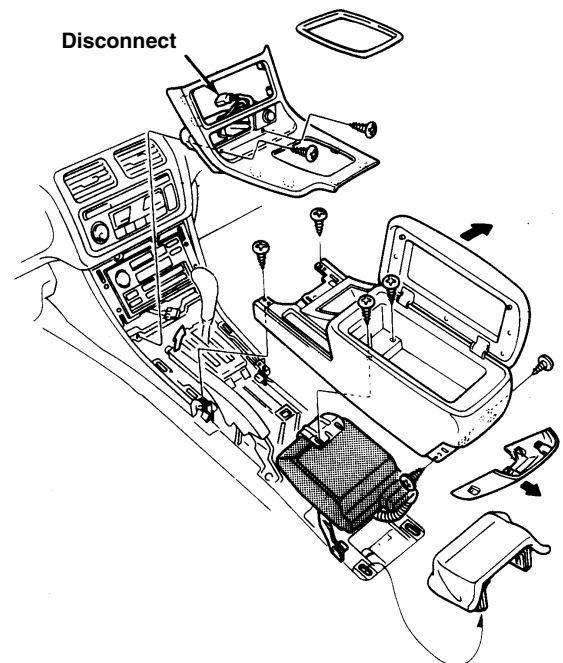
1. Remove the two mounting screws from the center console panel. Remove the shift indicator garnish and the center console panel. Disconnect the 6 pin connector.
2. Remove six mounting screws and remove the center armrest.

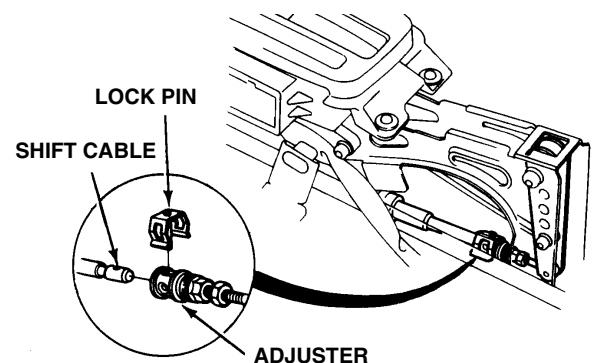
3. Move the shift lever to Reverse. Remove the shift cable adjuster lock pin.

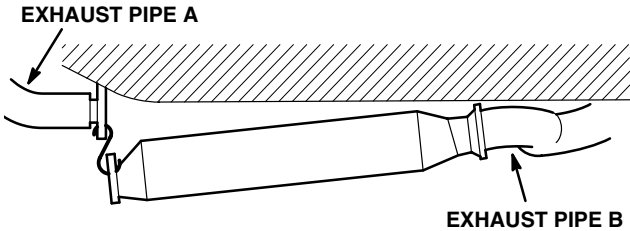
4. Raise the car on a hoist. Wrap a cloth around the muffler outlet pipes so they do not mar the bumper.
5. Remove the hangers from exhaust pipe B. Use Acura Rust Penetrant or silicone spray to ease removal.
6. Remove the front mounting bolts from the catalytic converter. Lower the front of the converter about 4" and suspend it with a piece of wire.

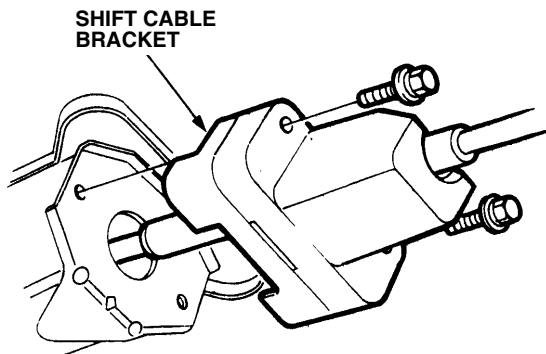
7. Remove the seven forward mounting bolts from the heat shield and let it rest on the converter. There is no need to loosen the two rear bolts.
8. Remove the tunnel beam (four bolts).
9. Remove two shift cable bracket bolts. Pull the cable out of the hole.

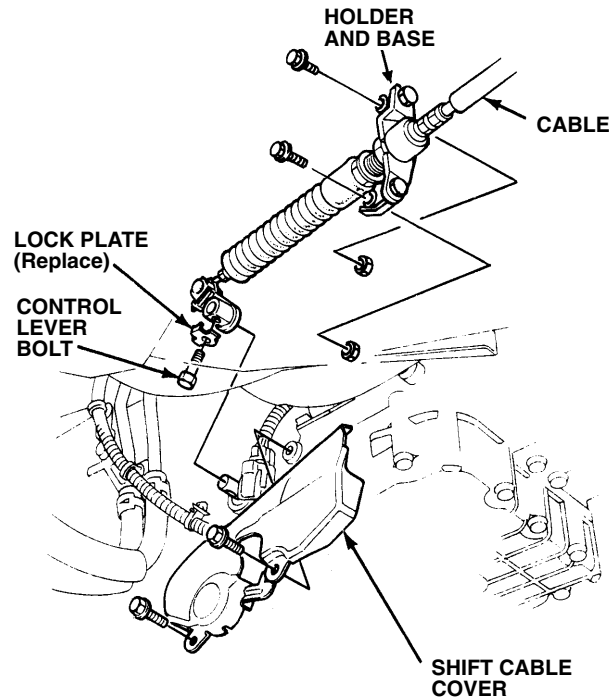
12. Remove the shift cable holder base mounting bolts from the transmission. Remove the shift cable, holder and base as an assembly. Do not unbolt the shift cable holder from the holder base.

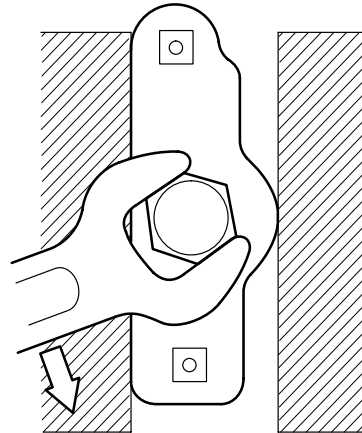
13. Clamp the cable/holder/base assembly in a vise. Loosen the locknut and remove the cable from the holder.

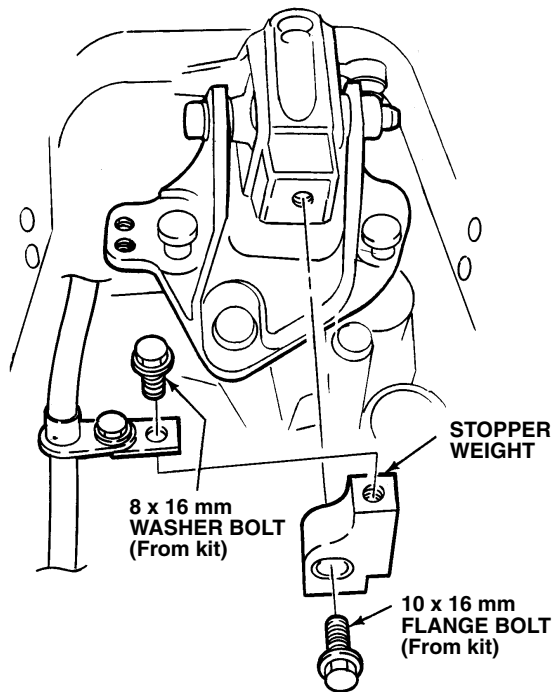
- Remove the transmission stopper weight. Install the new stopper weight with the 10x16 mm flange bolt from the kit.

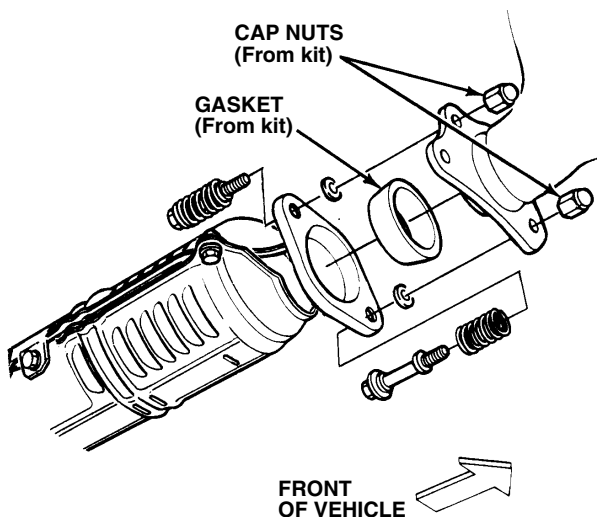
- Attach the shift cable guide to the stopper weight. Use the 8x16 mm washer bolt from the kit.
- Install the tunnel beam (four bolts).
- Reinstall the heat shield to the floor (seven bolts).
- Reconnect the catalytic converter to exhaust pipe A. Use the new exhaust gasket and cap nuts from the kit.

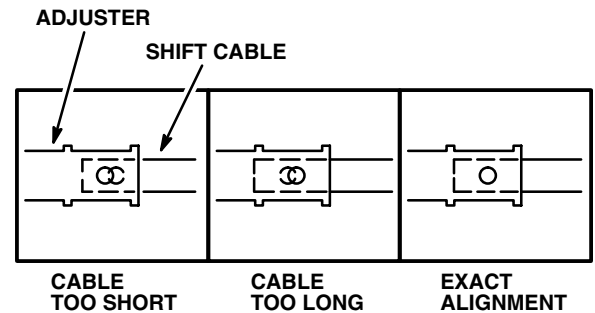
- Attach the shift cable to the link with the lock pin.
- Set the parking brake and press on the brake pedal so the car will not move. Start the engine and move the shift lever to Reverse. Turn off the engine.
- Remove the lock pin from the cable adjuster. Check the alignment of the hole in the adjuster to the hole in the shift cable. If they are not perfectly aligned, loosen the locknut and adjust as needed. Tighten the locknut.

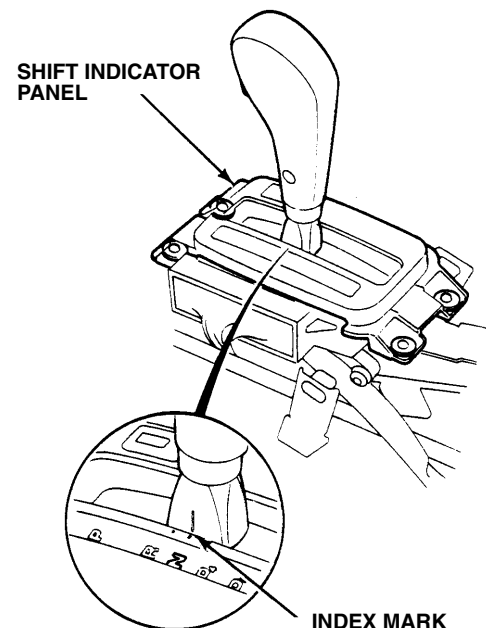
- Reinstall the lock pin.
- Press on the brake pedals, start the engine. Move the shift lever to Neutral. Verify that the index mark on the shift lever aligns with the N mark on the shift indicator panel when the transmission is in Neutral.
- With your foot on the brake, shift slowly from Neutral to Reverse and Neutral to Drive. Using the R and D4 marks for reference, note the position of the shift lever index mark when the transmission engages each gear. Reverse and Drive should each engage an equal distance from Neutral. If one is closer than the other, remove the shift cable adjuster lock pin and adjust the linkage accordingly.

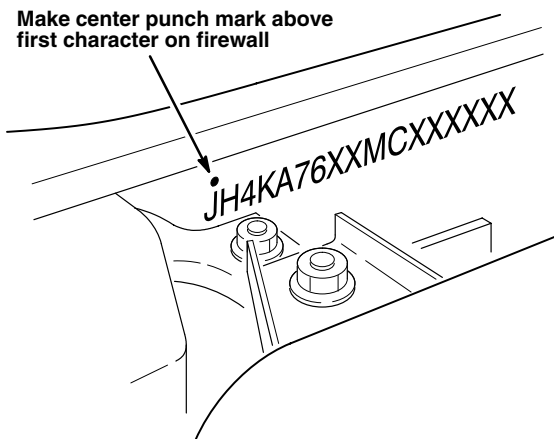
34. Center punch a completion mark above the first character of the VIN on the engine bulkhead.
