Buzzing From the Seat Belt Shoulder Anchor

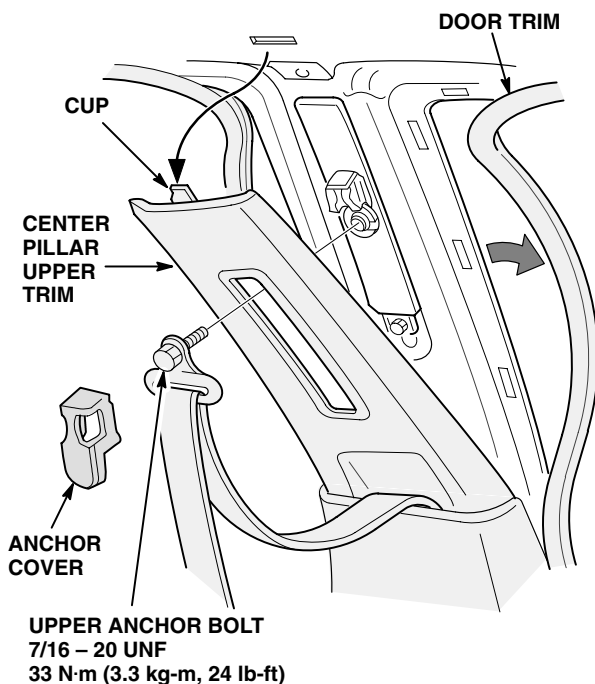
1. Remove the front and rear door trim along the upper half of the B pillar.
2. Remove the anchor cover and the seat belt anchor bolt.
3. Pull the top of the B pillar upper trim away from the body so you can access the seat belt track cover. You do not need to completely remove the trim piece.

The plastic cover on the seat belt shoulder anchor is contacting the seat belt track.

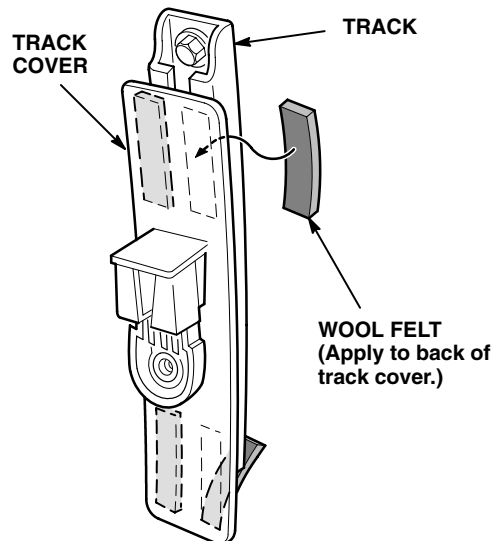
4. Cut four 6 mm wide pieces of wool felt. Apply them to the track cover between the cover and the track.

Cushion the seat belt track cover with wool felt (see REQUIRED MATERIALS).
