YEAR  
1991-92

MODEL  
LEGEND  
4-DOOR

BULLETIN NO.  
93-017

## Paint Peeling From Door Mirror

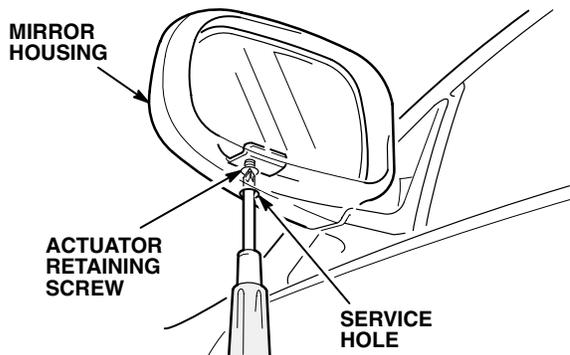
1. Open the window of the front door.
2. Insert a #2 Phillips screwdriver through the service hole in the bottom of the mirror housing. Loosen the actuator retaining screw, but do not remove it.

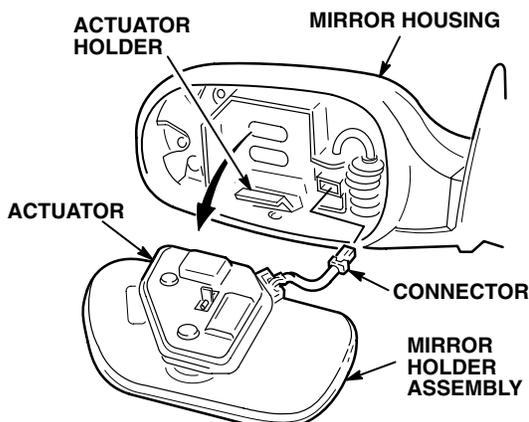
3. Remove the actuator and the mirror holder assembly from the mirror housing; then, disconnect the connector.

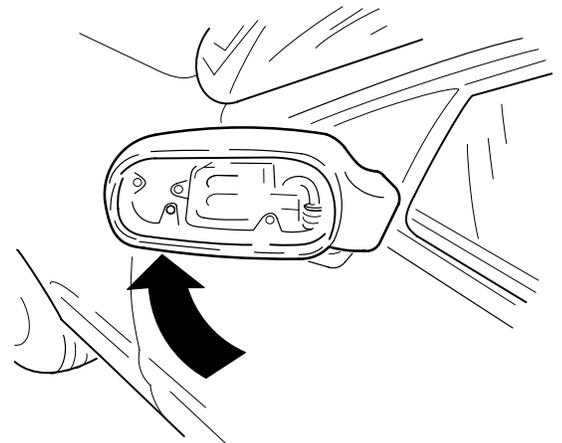
4. Pivot the mirror housing towards the front of the car until it locks in place.

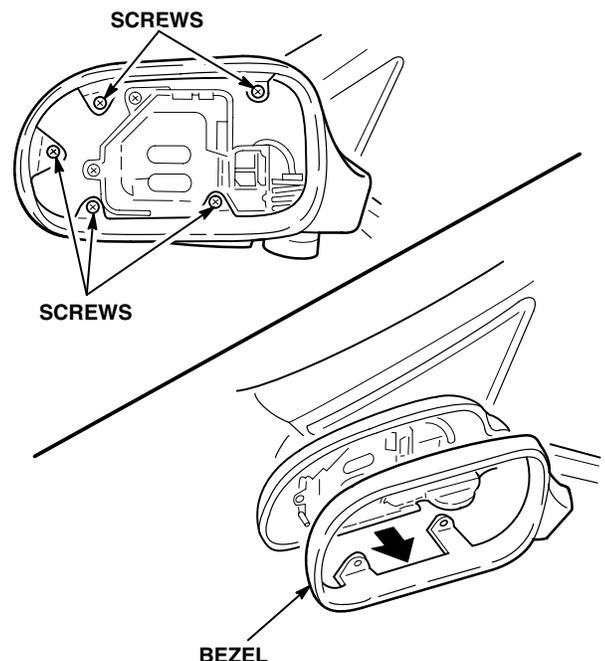
5. Remove the five screws that attach the bezel to the mirror housing. Pry the outer edge of the bezel away from the housing to release the clips on the pivot end.

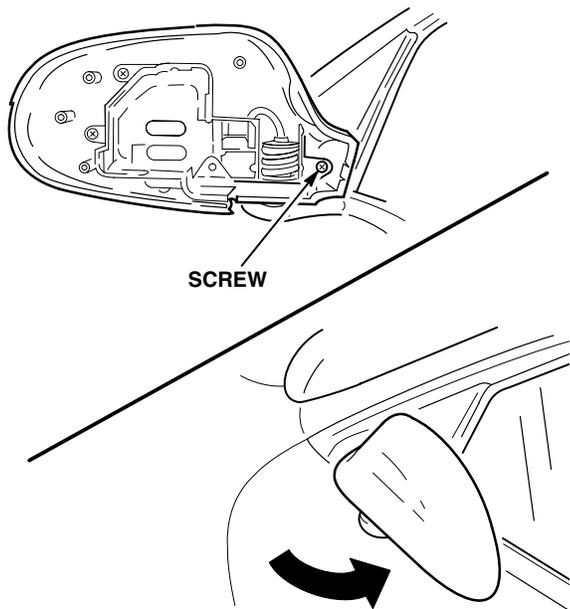
- Remove the screw at the pivot attaching the mirror housing to the frame. Pivot the housing all the way towards the side window until it locks in place.

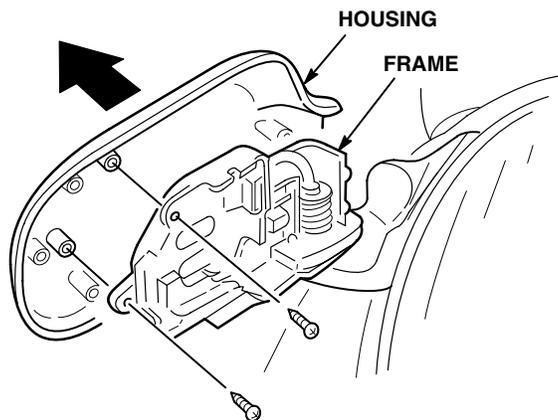
- Remove the last two screws attaching the mirror housing to the frame; then, remove the housing.

- Install the new mirror housing and bezel in reverse order of removal.
