BULLETIN NO.
91-029

Gap Between Dashboard and Lower Dashboard Cover

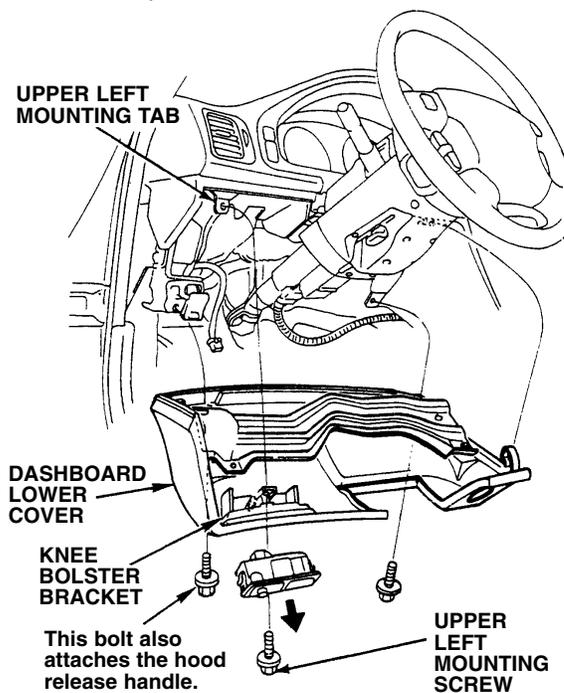
1. Remove the courtesy light controller (LS) or the plastic cover (STD, L) from the lower dashboard cover.

2. Remove the three lower dashboard cover mounting screws, then remove the cover.

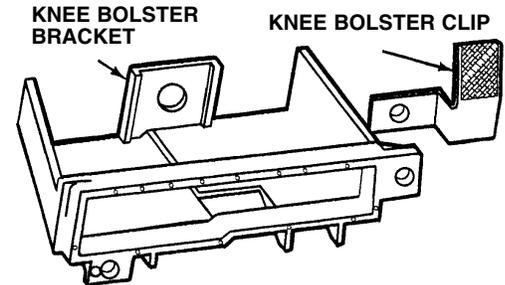
3. Install the knee bolster clip under the right knee bolster bracket mounting screw.

4. Make sure the ignition switch grommet is positioned correctly, then insert the lower dashboard cover's upper right mounting clip into the slot in the dashboard.
5. Install all three cover screws finger-tight. While pushing the cover up and forward, tighten the upper left screw first, followed by the lower left screw, then the lower right screw.
6. Reinstall the courtesy light controller (LS) or the plastic cover (STD, L). On LS models, turn on the headlights and make sure the courtesy light controller works properly.
