Front Bumper Face Pulls Loose

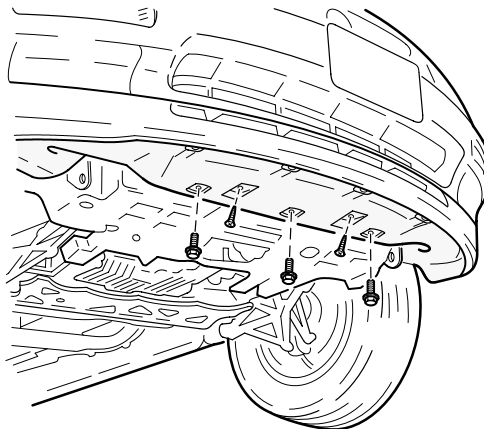
The lower bumper face pulls loose from its mounts if it comes in contact with a curb, parking lot divider, or similar object when the car is backing up.

1. Raise the vehicle on a hoist.
2. Remove the two lower bumper face plastic mounting fasteners.
3. Remove the three 6 mm bolts that mount the front of the splash shield to the subframe (visible through the square holes in the lower bumper face).
