MODEL
LEGEND
INTEGRA

BULLETIN NO.
92-026

Glove Box Light Stays On

(Supersedes 92-026, dated September 15, 1992)

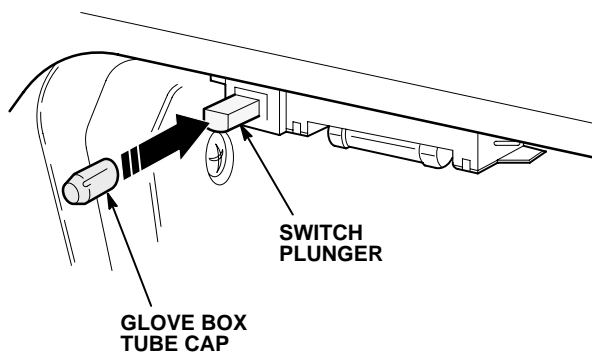
The glove box light stays on when the glove box lid is closed. This is noticeable at night when the headlights are on and the inside of the car is dark; you can see a glow around the glove box lid.

The glove box switch plunger is too short.

Install the glove box tube cap listed under PARTS INFORMATION to lengthen the switch plunger.

1. Using a sharp utility knife, shorten the glove box tube cap to 12 mm.
2. Press the tube cap over the glove box switch plunger.

3. Turn the headlights on, and confirm that the glove box light goes off when the glove box lid is closed.
