**ACURA ServiceNews**

BSN 16110 (9309)

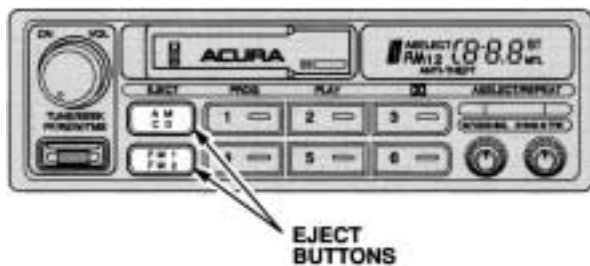
The owner's manual and the unit's faceplate both indicate that the AM/CD button is the cassette tape eject button. However, both the AM/CD button *and* the FM 1/FM 2 button will eject a tape. Why both? So you can select which audio function you want to return to after playing a tape.

If you eject the tape with the AM/CD button, the unit will return to the last function that was selected with that button (either AM or CD). Likewise, if you eject the tape with the FM 1/FM 2 button, the unit will return to the FM mode last selected.
