Latest PGM Tester Software Is SN010P

ACURA ServiceNews

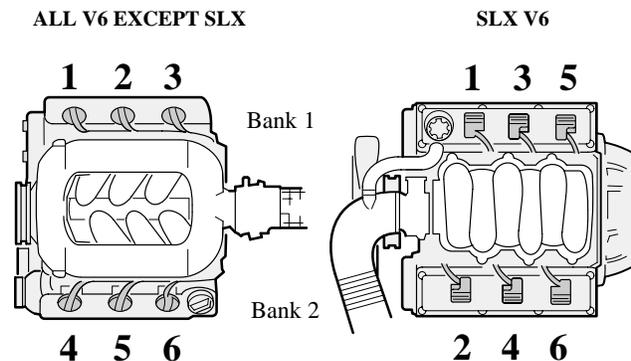
V6 Firing Order

On all V6 models except SLX, the firing order is 1-4-2-5-3-6. Looking at the crankshaft pulley end of these engines, the left bank of cylinders (bank 1) is numbered 1, 2, 3, and the right bank (bank 2) is 4, 5, 6.

On an SLX, the firing order is 1-2-3-4-5-6. From the crankshaft pulley end of the engine, the left bank of cylinders (bank 1) is numbered 1, 3, 5, and the right bank (bank 2) is 2, 4, 6.
