Wind Noise From Door Glass

(Supersedes 91-012, dated February 2, 1992)

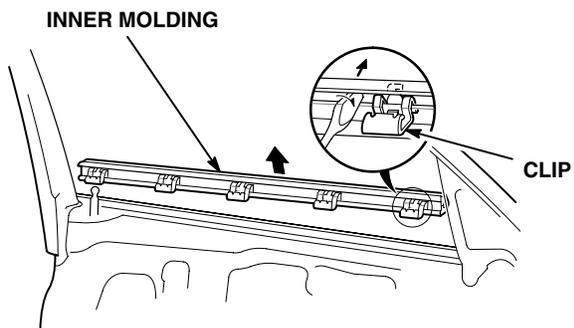
Inspect the glass run channel for distortion or damage. While test driving the car, use a stethoscope to listen for air leaks. Replace the run channel if it is damaged, or if it leaks air and the glass is adjusted properly.

- Remove the door panel. Use a razor blade to cut the adhesive for the plastic cover. Remove the plastic cover.
- Remove the inner molding.
 - Remove the door panel. Use a razor blade to cut the adhesive for the plastic cover. Remove the plastic cover.
 - Remove the inner molding.
