BULLETIN NO.
91-031

ABS Problem Code 1-8

(Supersedes 91-031, dated May 20, 1991)

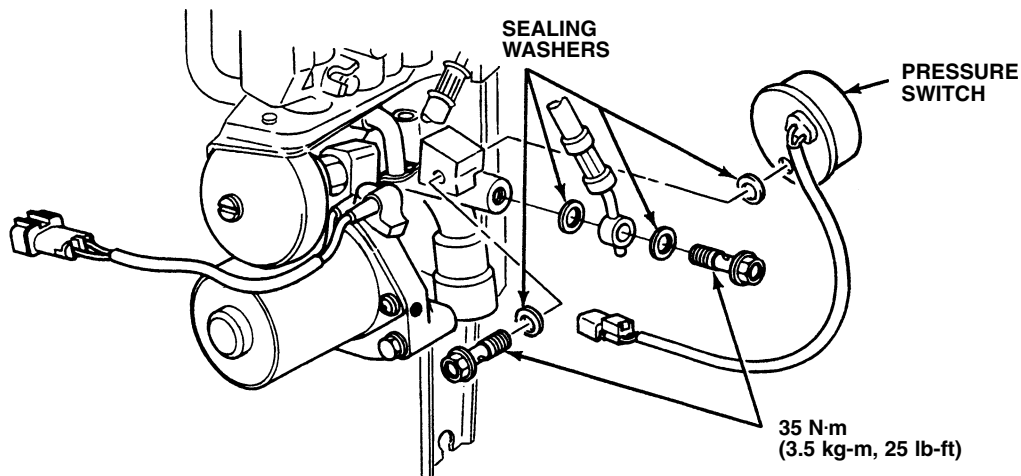
1. Remove the ABS modulator/power unit assembly as described in Service Bulletin 91-026, "ABS Modulator Unit and Power Unit Replacement."
2. Remove the high-pressure hose from the pump so you can replace the pressure switch.
3. Remove the original pressure switch, and install the new switch using new sealing washers (see PARTS INFORMATION).
4. Reconnect the high-pressure hose using new sealing washers.
