MODEL
LEGEND
INTEGRA
VIGOR
TL

BULLETIN NO.
95-010

Cable Reel Holding Fixture

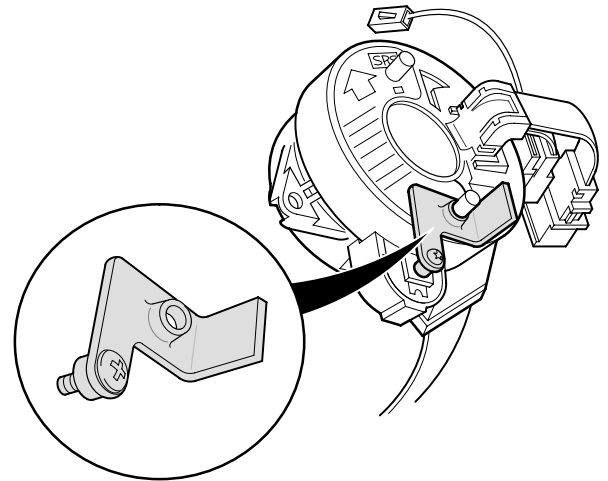
METAL FIXTURE

2. Verify that the cable reel is centered; the yellow gear tooth is lined up with the alignment mark on the cover. Install the cable reel holding fixture in the cable reel assembly as shown. Use a Torx T-10 wrench.

FOR 1992-94 VIGOR AND 1995-96 TL

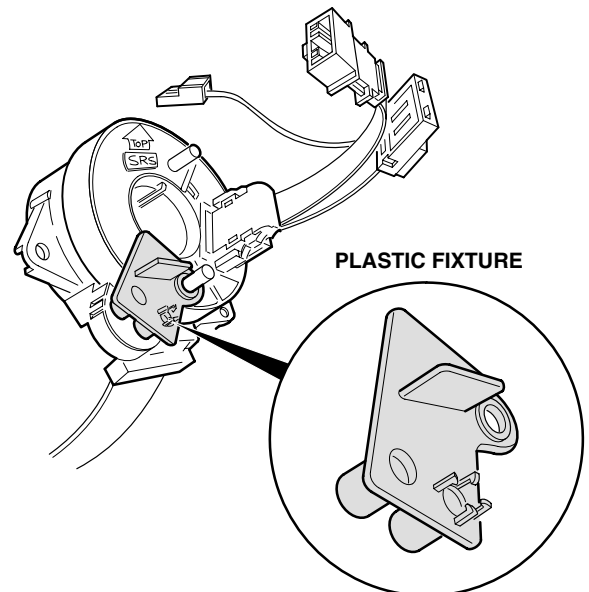
PLASTIC FIXTURE

FOR 1991-95 LEGEND AND 1994-95 INTEGRA
